Longitudinal Bulkhead
H.W.B.T No.4
Portside

m/v "HALTBakk COMABAR"
IMO No:8411231
Report No.CYS-25/81

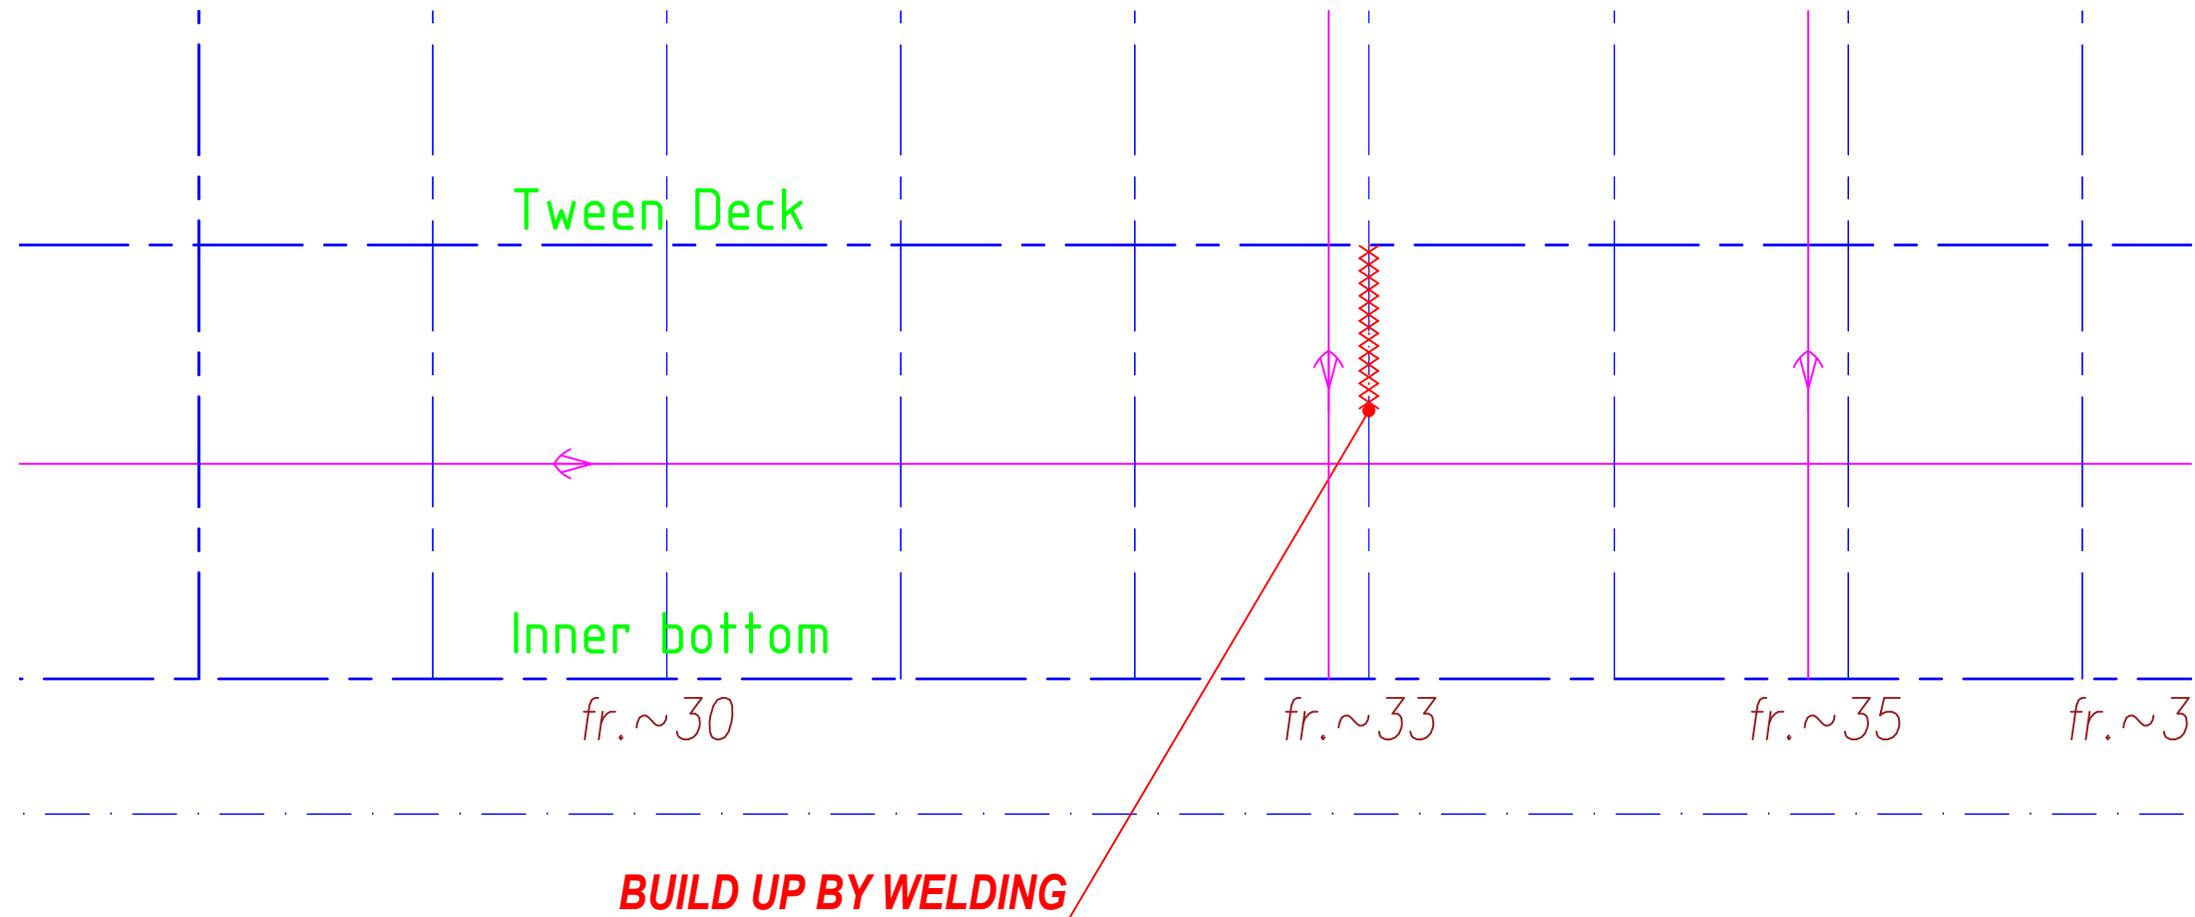
Notes: ALL DIM GROOVING CORROSION ON PLATES- DIMENSION ~ 30-40%

BUILD UP BY WELDING

Grade "A"

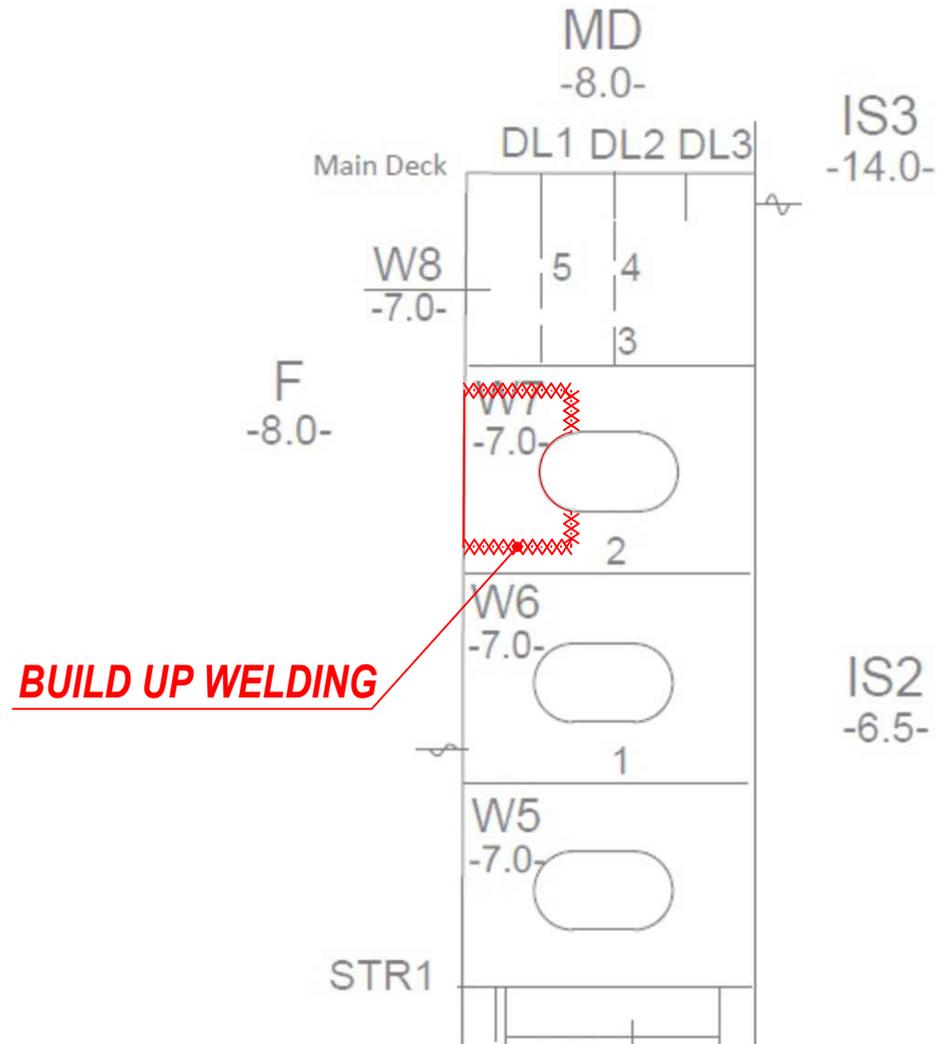
W.W.B.T No.5
Portside

Notes:
GROOVING CORROSION ON PLATES- DIMENSION ~ 30-40%
ALL DIMENSIONS TO BE DEFINED MORE EXACTLY IN PROCESS OF REPAIR.
Grade "A"

BUILD UP WELDING

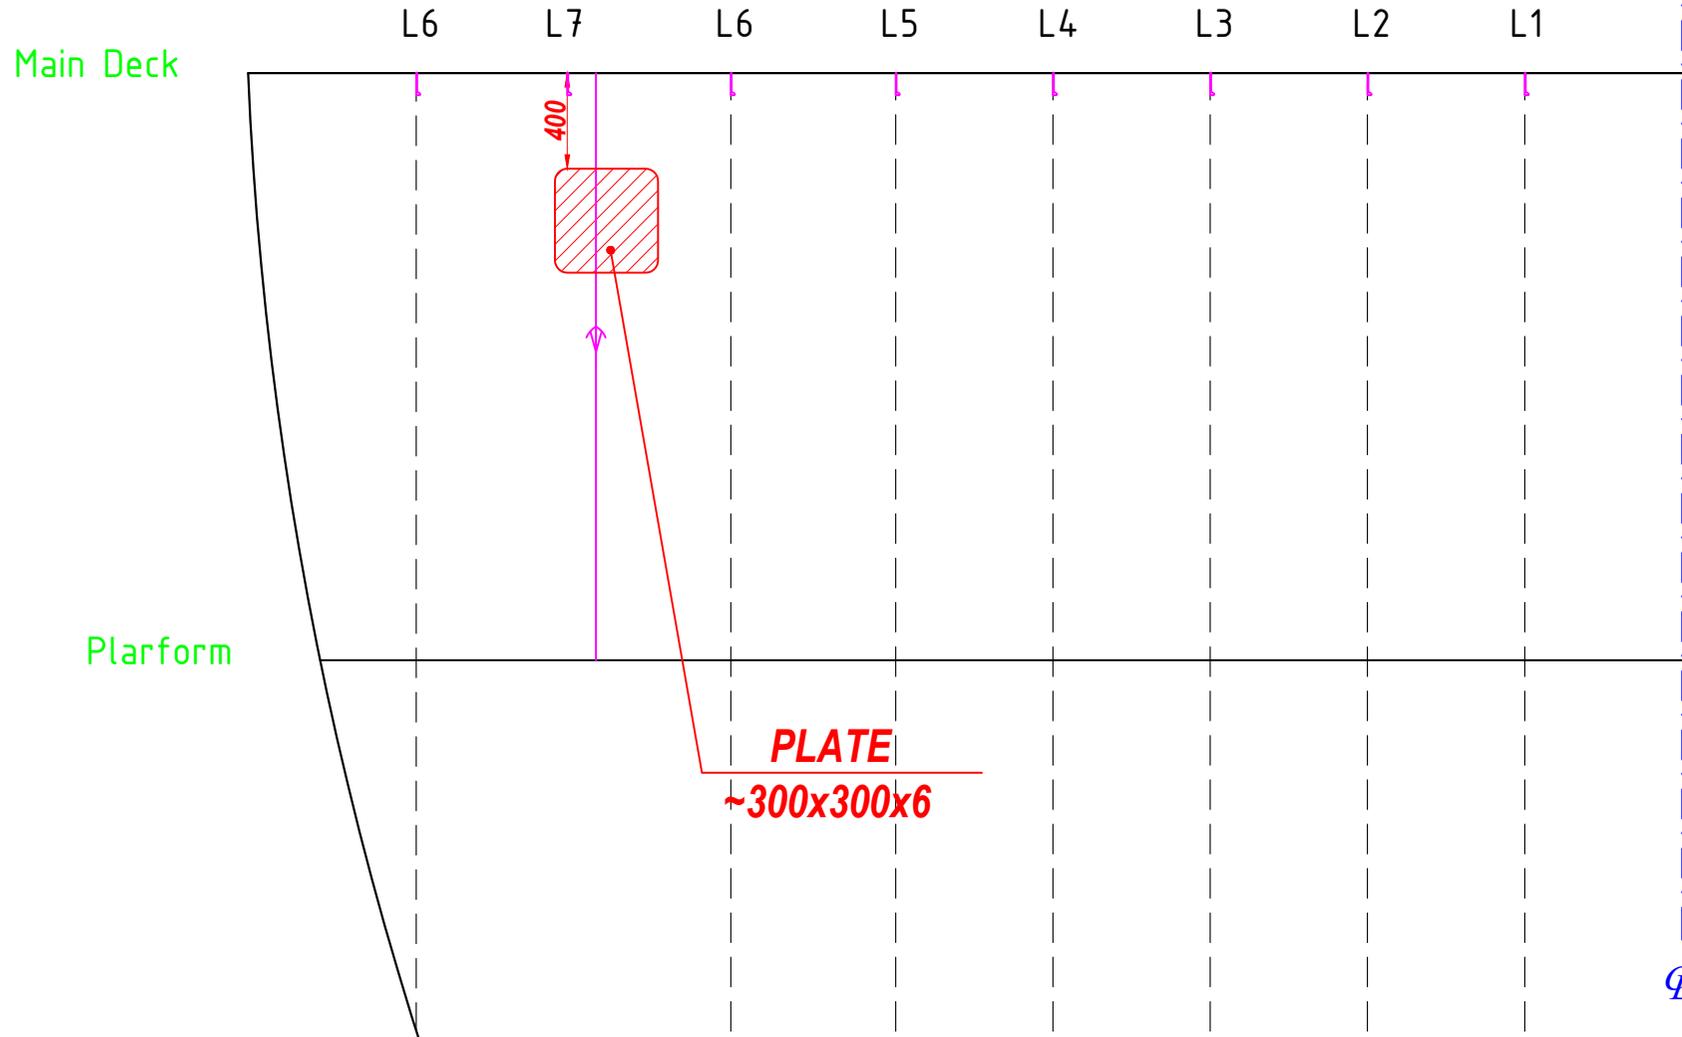
Transverse Bulkhead
Frame 20
Portside

Notes:
GROOVING CORROSION ON PLATES- DIMENSION ~ 30-40%
ALL DIMENSIONS TO BE DEFINED MORE EXACTLY IN PROCESS OF REPAIR.
Weight ~4 kg Grade "A"

- Renew plate

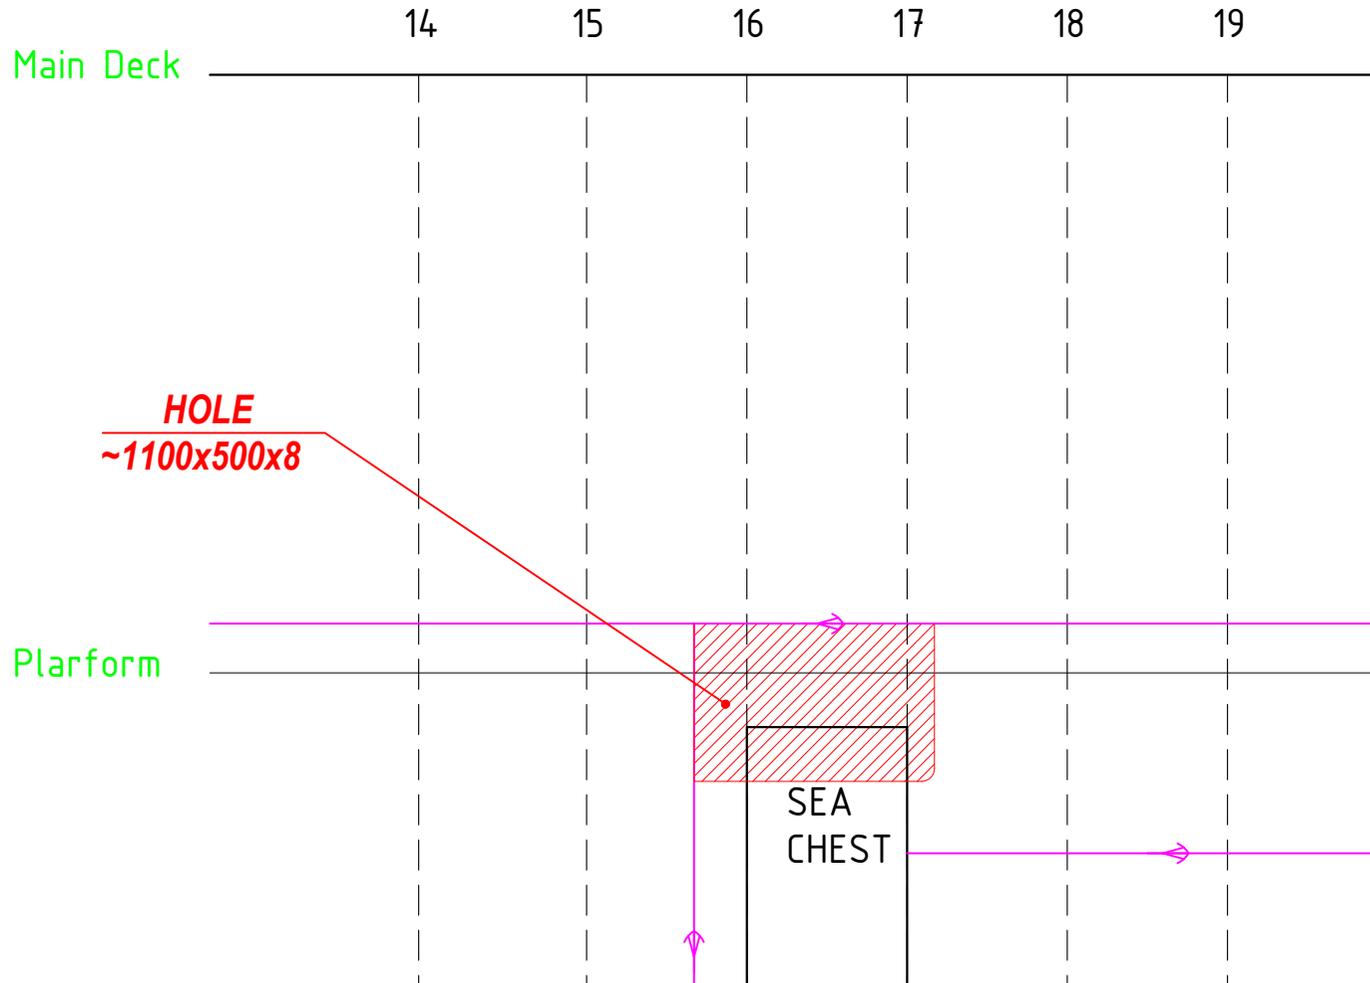
Engine room
Shell Plating
Portside

Notes:
GROOVING CORROSION ON PLATES- DIMENSION ~ 30-40%
ALL DIMENSIONS TO BE DEFINED MORE EXACTLY IN PROCESS OF REPAIR.
Weight ~35 kg Grade "A"

- Renew plate

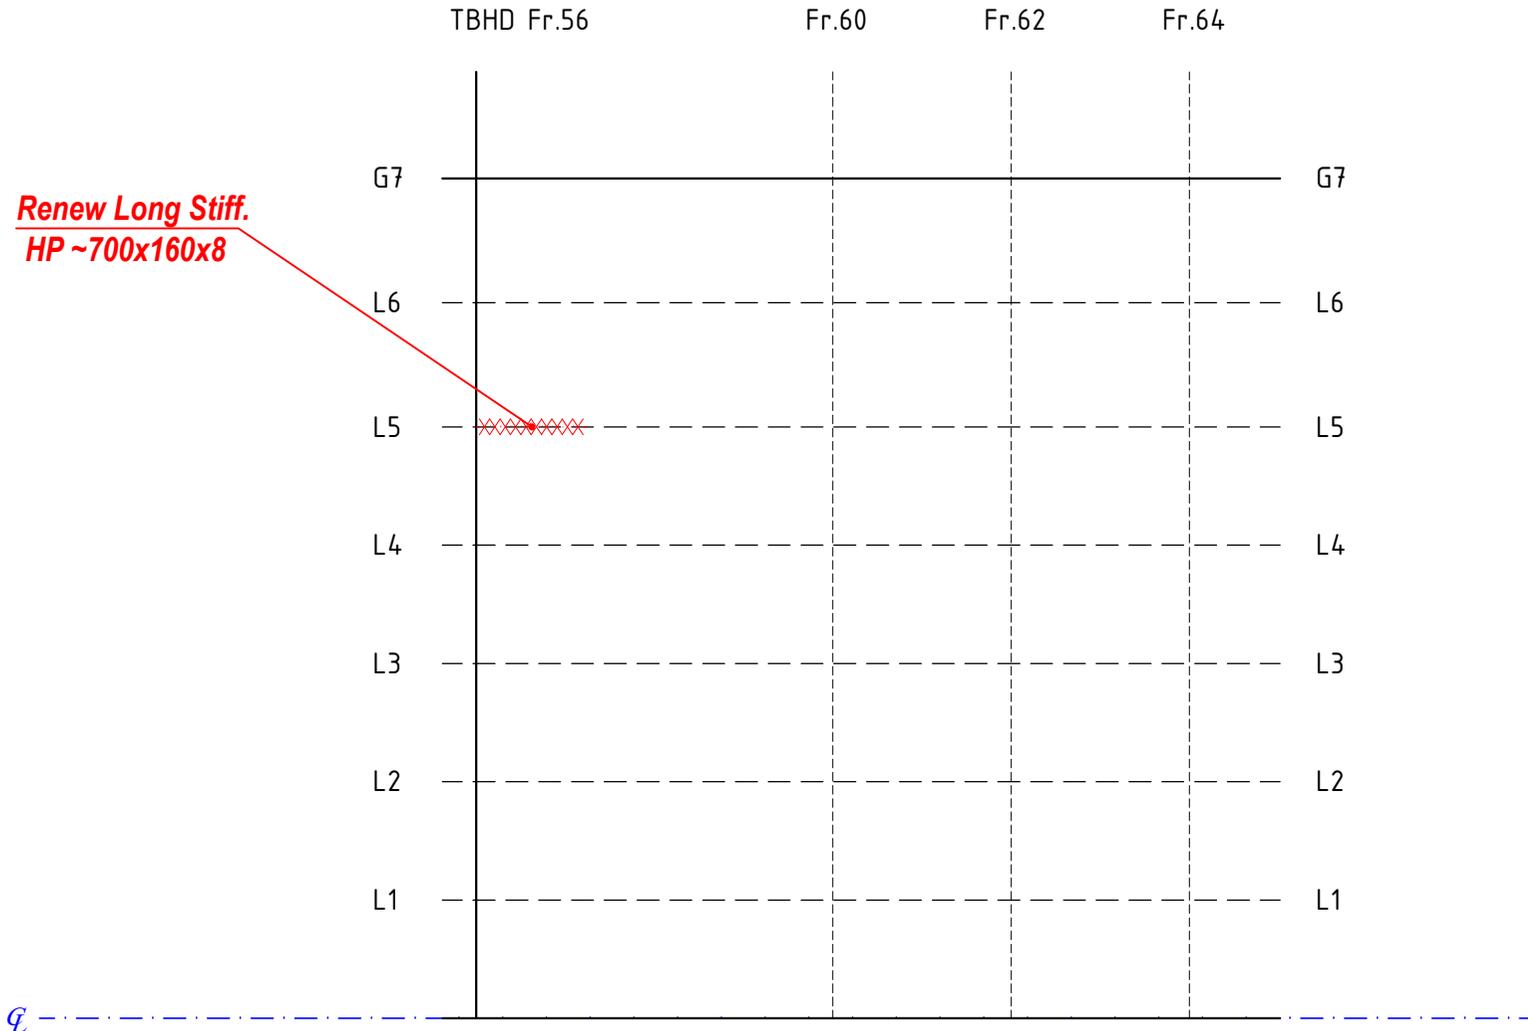
D.B.W.B.T No.2
Bottom
Portside

Notes:
GROOVING CORROSION ON PLATES- DIMENSION ~ 30-40%
ALL DIMENSIONS TO BE DEFINED MORE EXACTLY IN PROCESS OF REPAIR.
Weight ~7 kg Grade "A"

Repair recommendations:
XXXXXXXX - TO BE RENEWED STIFF.

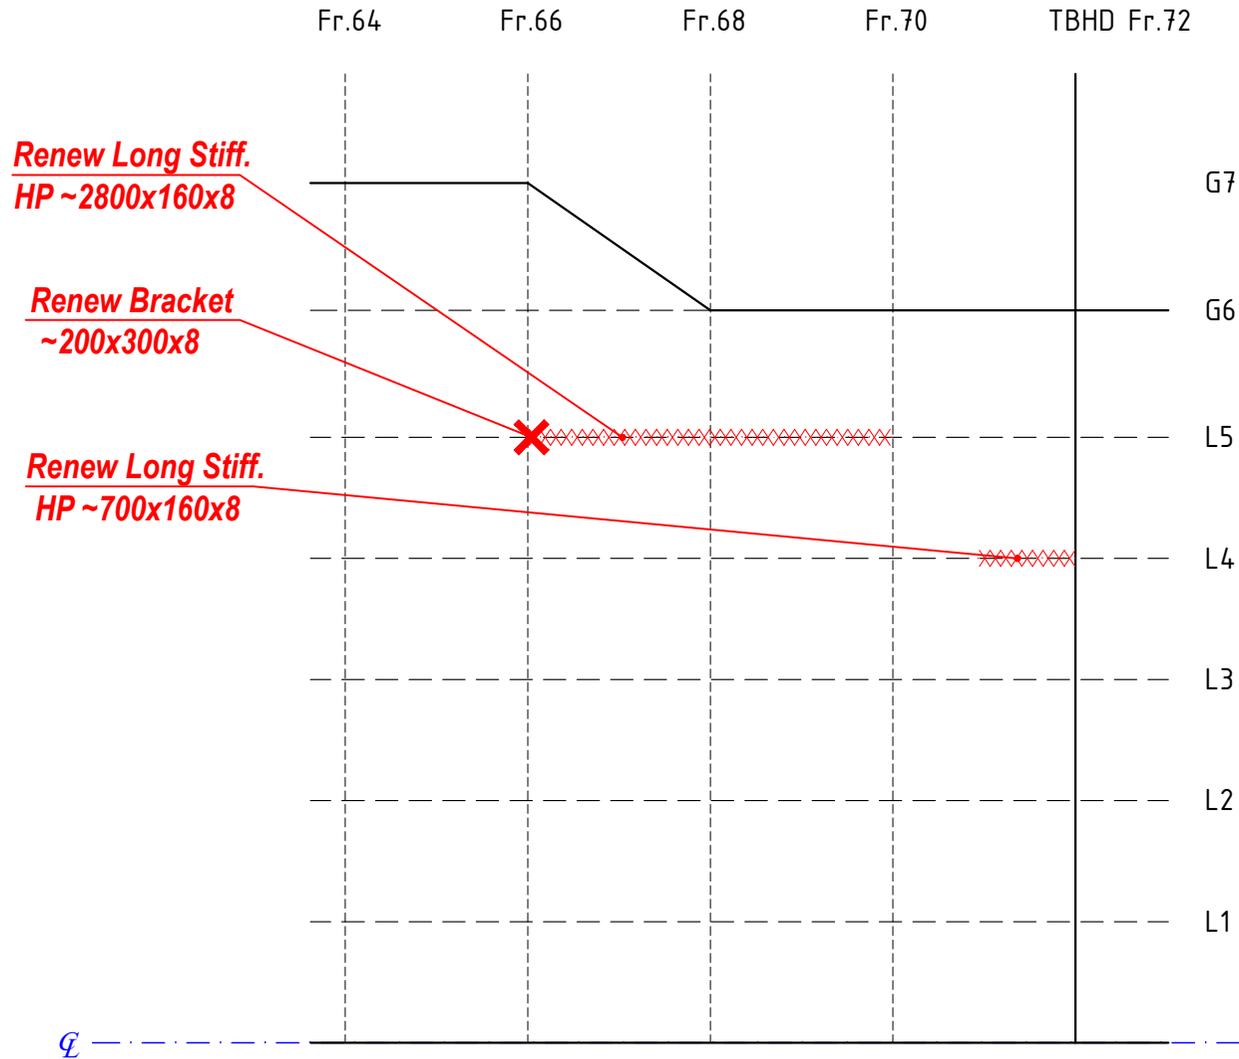
D.B.W.B.T No.2
Bottom
Portside

Notes:
GROOVING CORROSION ON PLATES- DIMENSION ~ 30-40%
ALL DIMENSIONS TO BE DEFINED MORE EXACTLY IN PROCESS OF REPAIR.
Weight ~40 kg Grade "A"

Repair recommendations:
XXXXXX - TO BE RENEWED STIFF.
X - TO BE RENEWED BRACKETS

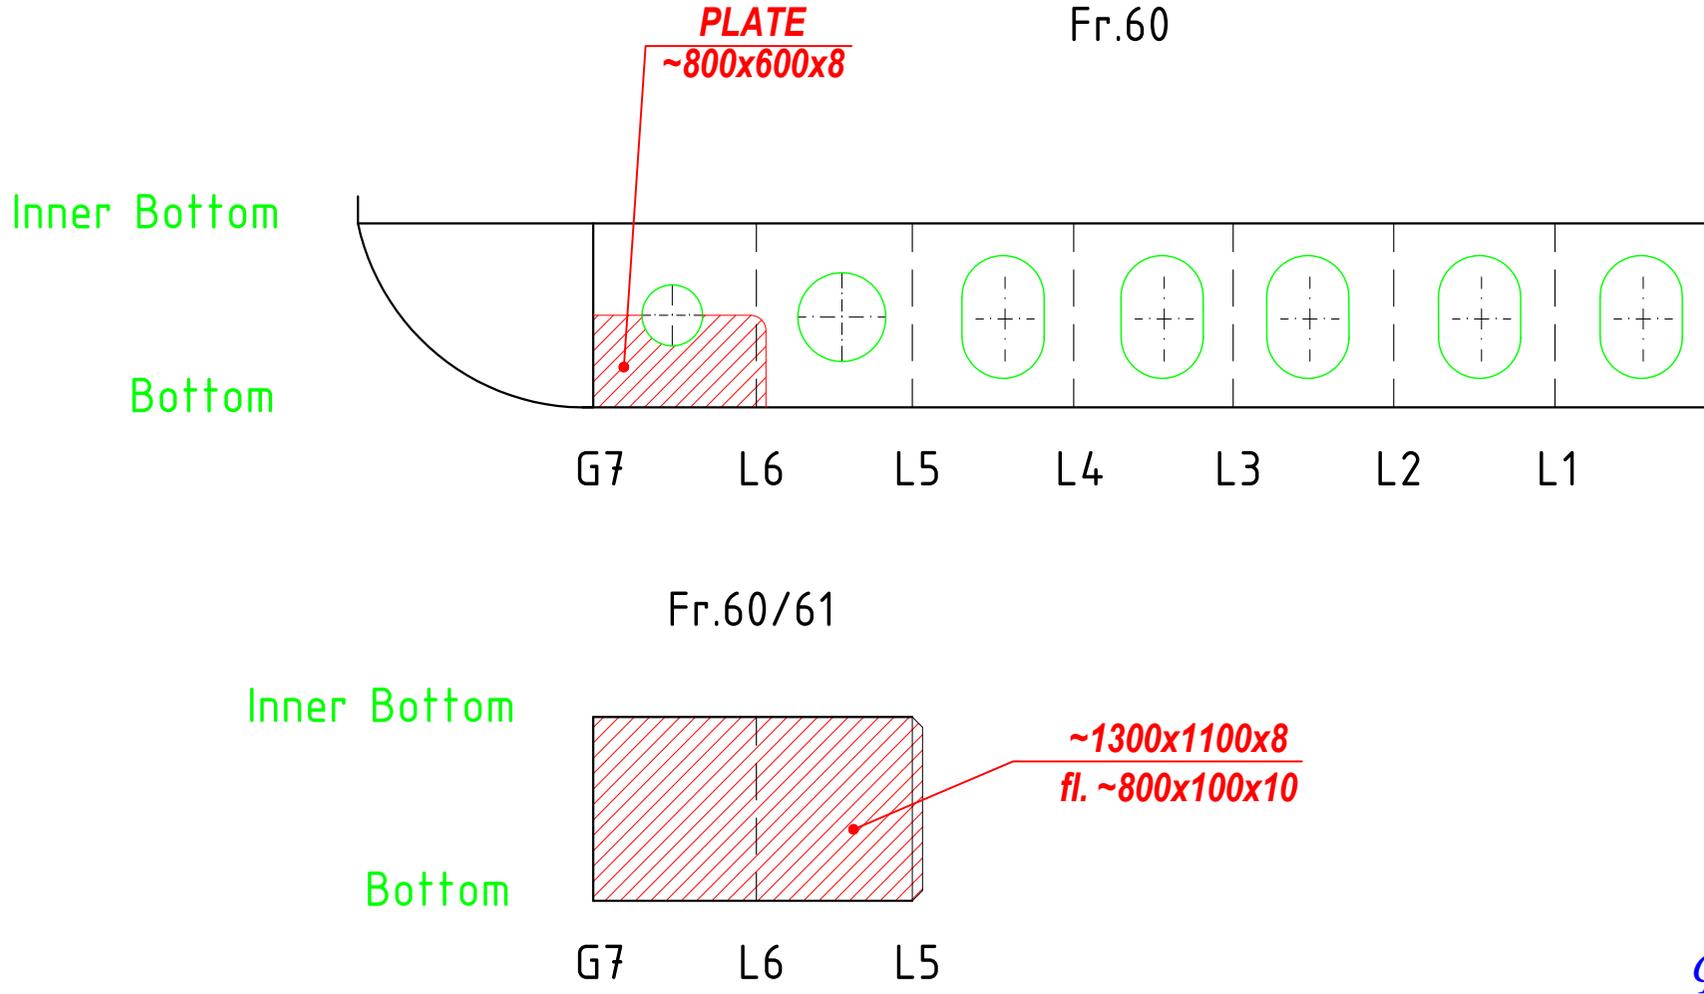
D.B.W.B.T No.2
Frames 60 & 60/61
Portside

Notes:
GROOVING CORROSION ON PLATES- DIMENSION ~ 30-40%
ALL DIMENSIONS TO BE DEFINED MORE EXACTLY IN PROCESS OF REPAIR.
Weight ~129 kg Grade "A"

- Renew plate

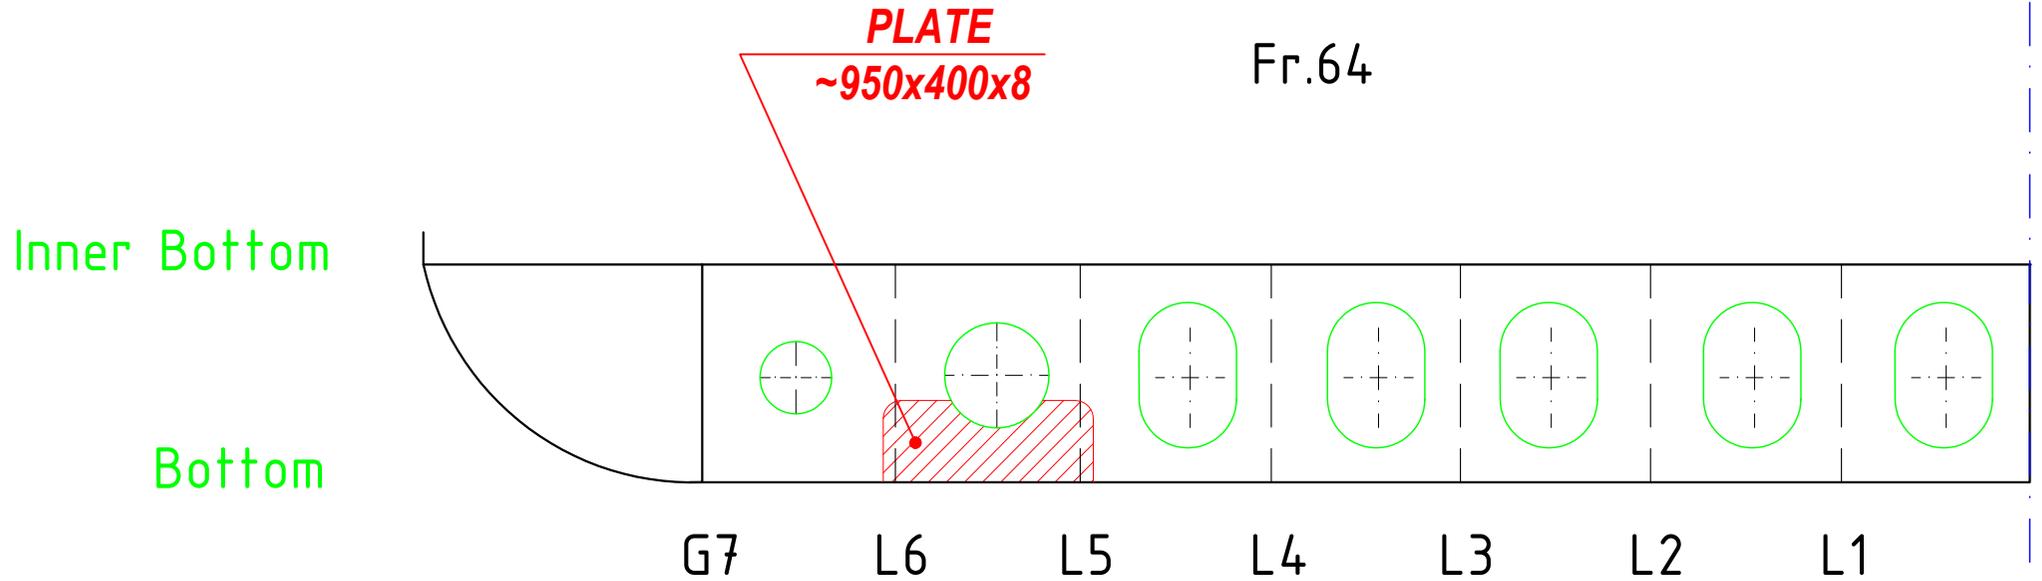
Notes:
GROOVING CORROSION ON PLATES- DIMENSION ~ 30-40%
ALL DIMENSIONS TO BE DEFINED MORE EXACTLY IN PROCESS OF REPAIR.
Weight ~24kg Grade "A"

- Renew plate

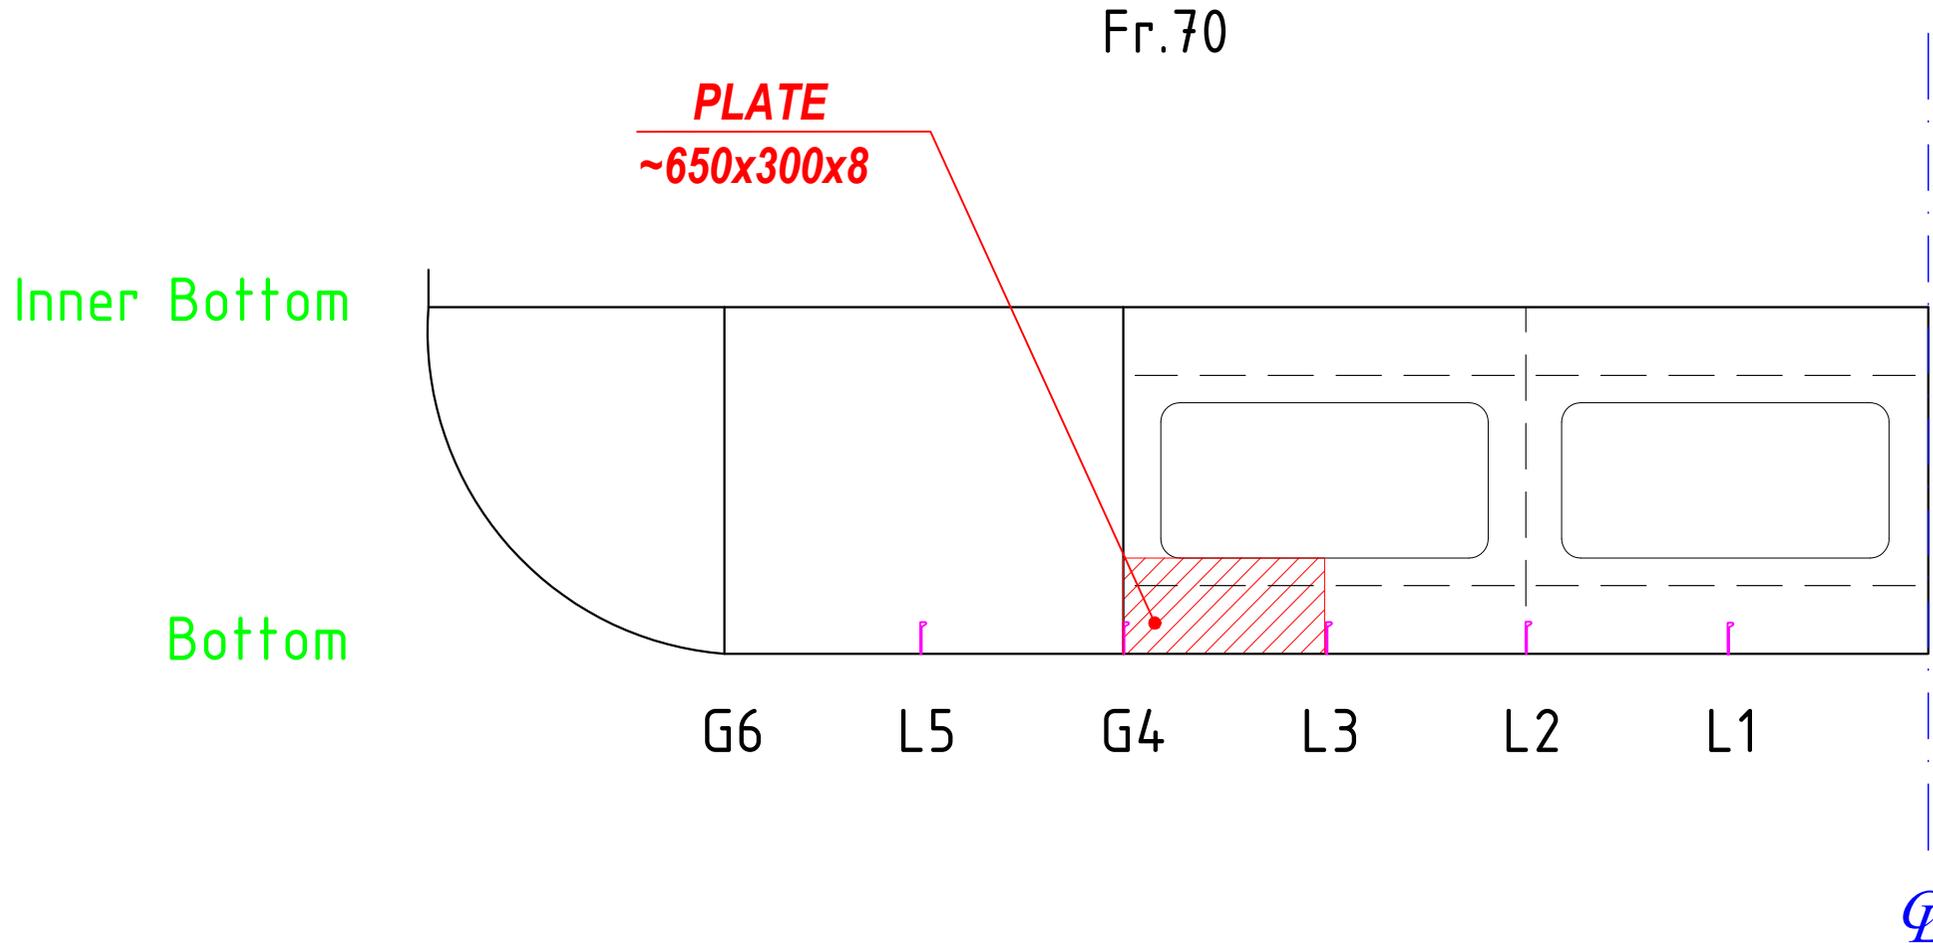
Notes:
GROOVING CORROSION ON PLATES- DIMENSION ~ 30-40%
ALL DIMENSIONS TO BE DEFINED MORE EXACTLY IN PROCESS OF REPAIR.
Weight ~13 kg Grade "A"

- Renew plate

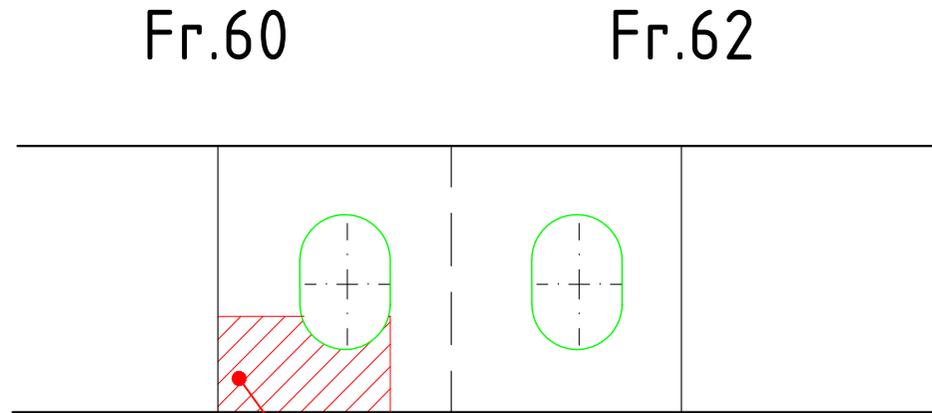
D.B.W.B.T No.2
2600 off CL
Portside

Notes:
GROOVING CORROSION ON PLATES- DIMENSION ~ 30-40%
ALL DIMENSIONS TO BE DEFINED MORE EXACTLY IN PROCESS OF REPAIR.

Weight ~12 kg Grade "A"

- Renew plate

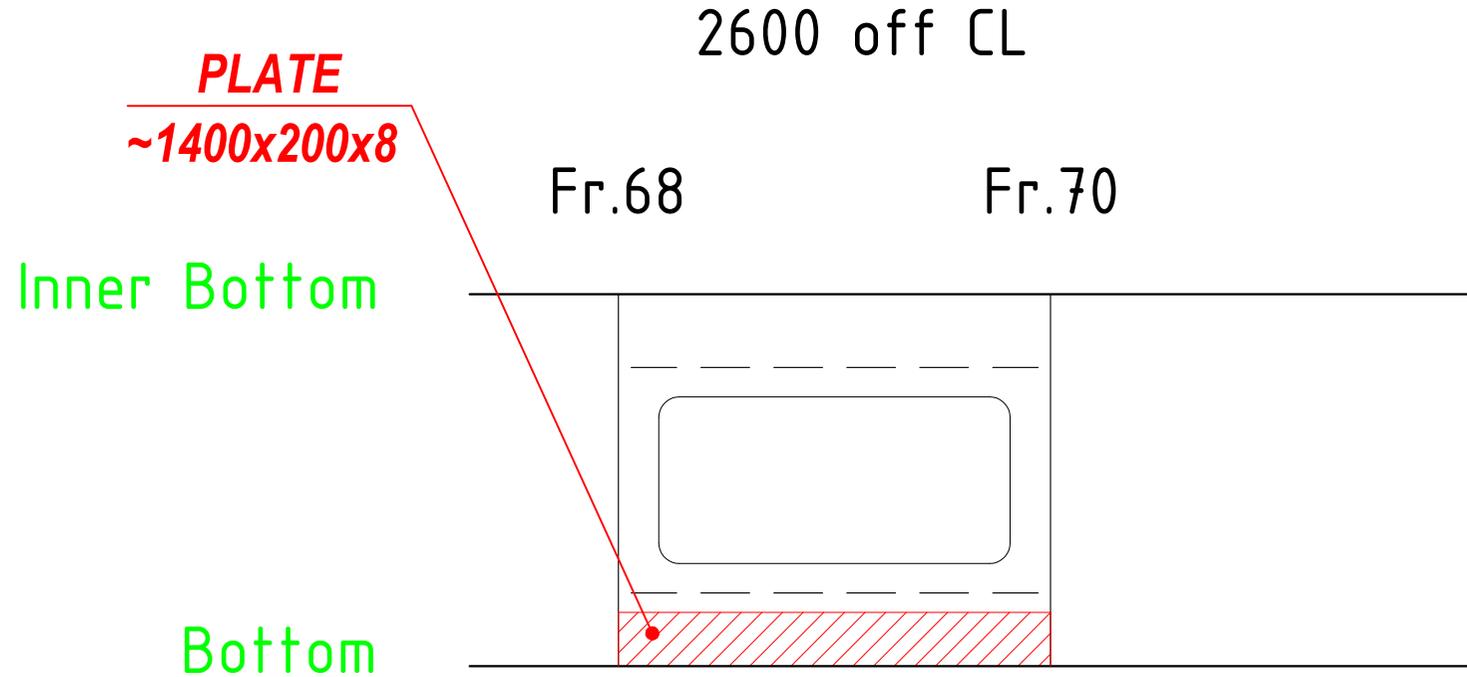
D.B.W.B.T No.2
2600 off CL
Portside

Notes:
GROOVING CORROSION ON PLATES- DIMENSION ~ 30-40%
ALL DIMENSIONS TO BE DEFINED MORE EXACTLY IN PROCESS OF REPAIR.
Weight ~18kg Grade "A"

- Renew plate
